Report of Japanese Government  
to the IAEA Ministerial Conference on Nuclear Safety  
- The Accident at TEPCO's Fukushima Nuclear Power Stations -

June 2011

Nuclear Emergency Response Headquarters  
Government of Japan

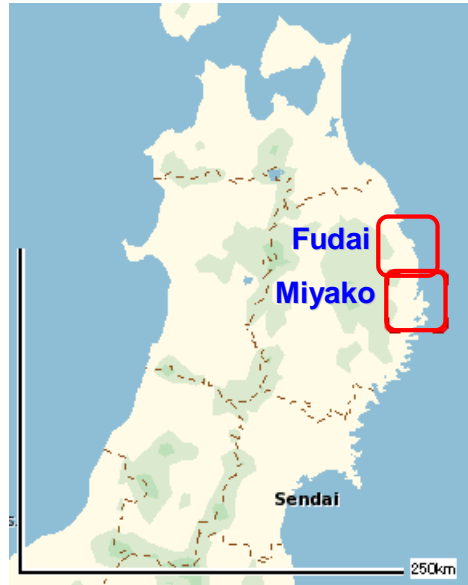
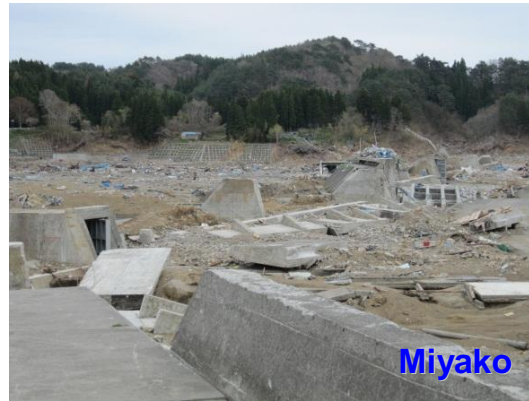
The 10m-high seawall was destroyed in Taro district, Miyako city, Iwate Pref.

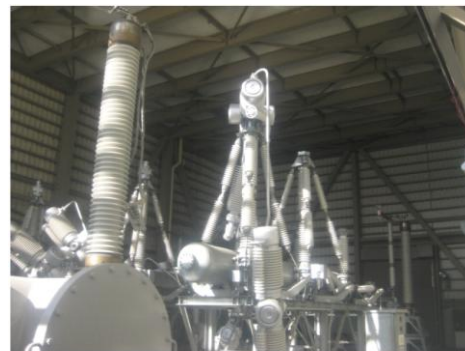
**Okuma line 2L (O-81)  
Circuit Breaker damaged**
