Report of Japanese Government  
to the IAEA Ministerial Conference on Nuclear Safety  
- The Accident at TEPCO's Fukushima Nuclear Power Stations -

June 2011

Nuclear Emergency Response Headquarters  
Government of Japan

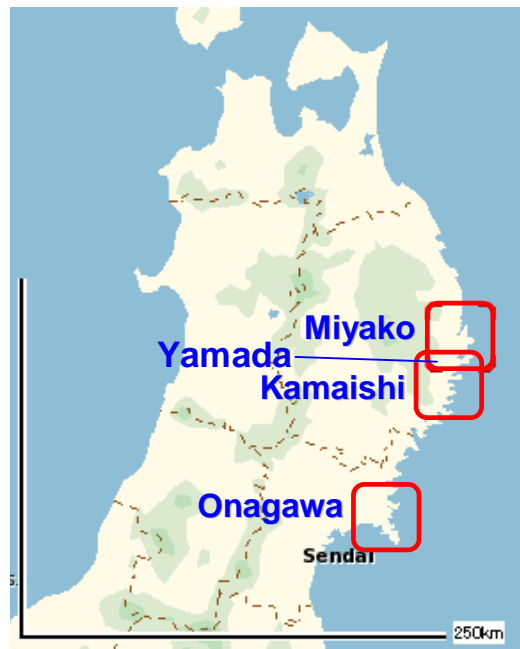
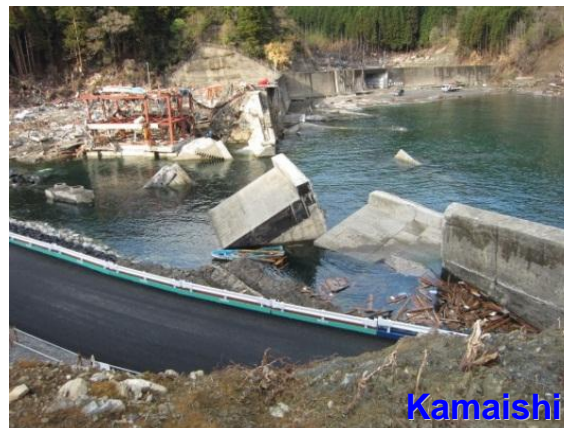
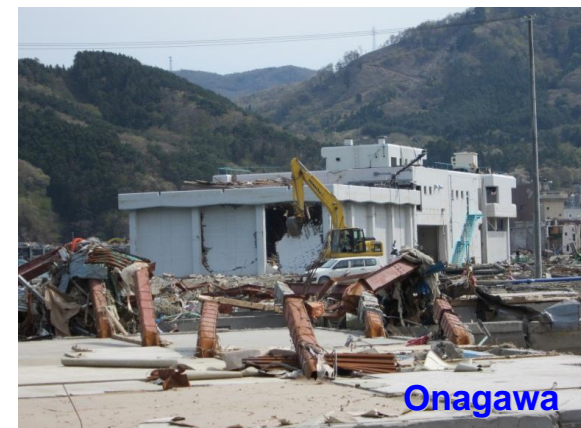
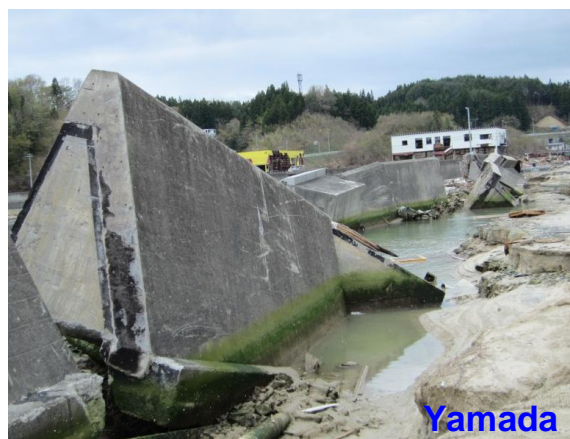
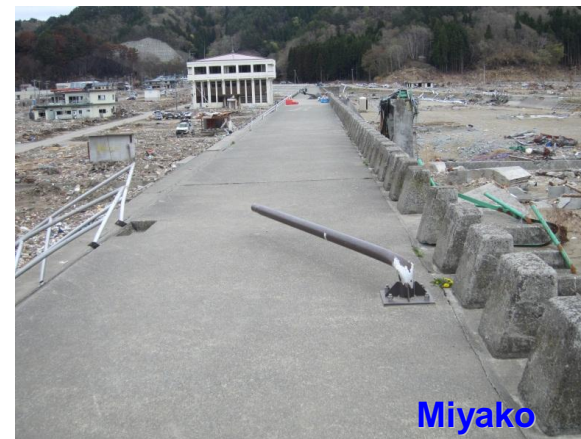
The ground around the bases of tidal embankments and seawalls were scoured by runups and rundowns and many of the bases were observed to have suffered collapses as shown in Fig. III-1-15. And the lining of embankments and seawalls (concrete portions that cover rocks and ground inside embankments) suffered boring from the lower edge of bases, and did not play a sufficient role in lessening the impact of the tsunami. Given this situation, there is the possibility that sand embankments would collapse through by scouring due to runups and rundowns and breakwater walls would be scoured or collapse if tsunamis breach the sand embankments when these are used as coastal defenses. Therefore technical guidelines should be prepared and organized for several kinds of countermeasures.

Destruction by tsunami scouring

Destruction by wave pressure

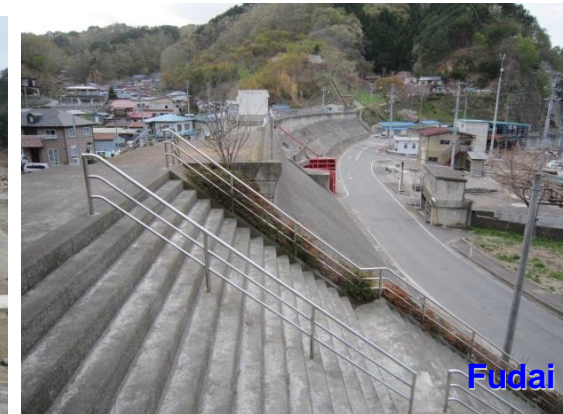
The 15.5m-high seawall was undestroyed in Otabe district, Fudai village, Iwate Pref.

Fig. III-1-16 Difference of seawall heights resulting in different consequence.

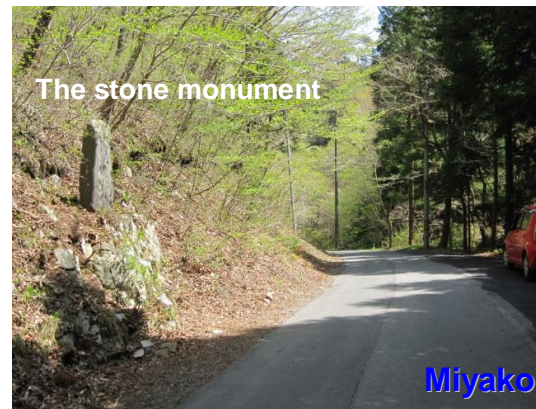
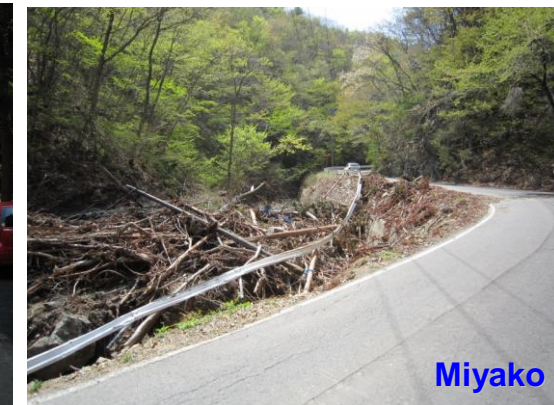
Fig. III-1-17 Photos of a stone monument and tsunami invading area below the stone monument.

In the Aneyoshi area, Miyako City in Iwate Prefecture, there is a stone monument with the warning not to build houses in the area lower than that point as shown in Fig. III-1-17 (left picture) at the entrance (height 60 m) of the village, showing lessons learned from runups of the two historical tsunamis mentioned above.

By observing this lesson, the area was able to avoid casualties this time even though the tsunami ran up (the actual runup height was 38.9 m) near the village as shown in the figure (right picture).

A photo from the village's point of view (i.e. facing the coast)

A photo from a viewpoint of facing the village taken at the spot slightly below the stone monument

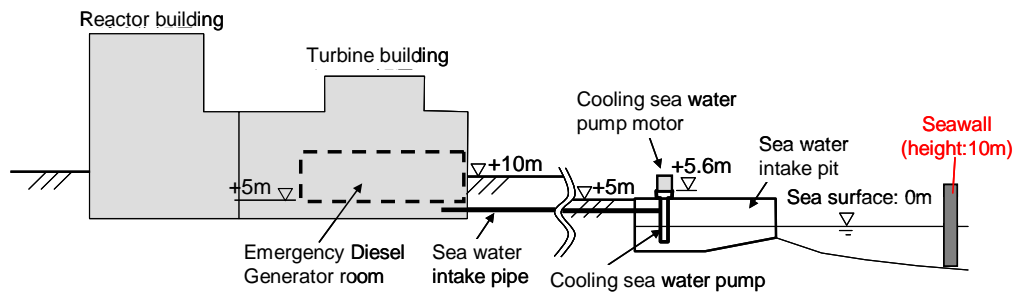
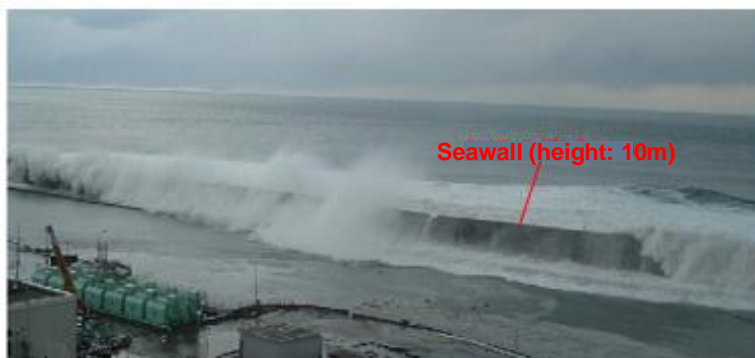
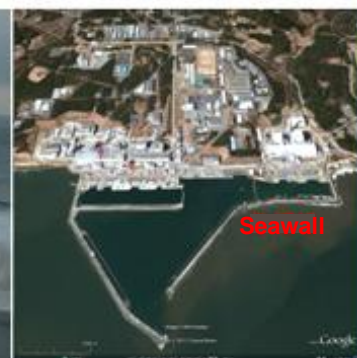
Fig. III-2-5 Tsunami getting over seawall at the Fukushima Dai-ichi NPS.

### Cross section of Fukushima Dai-ichi (Unit-1)

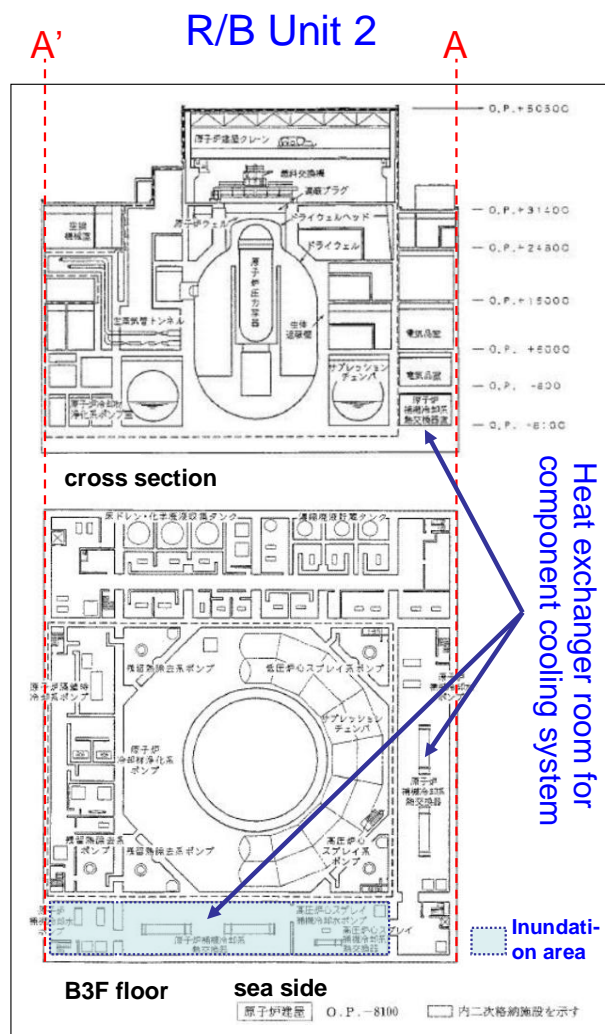
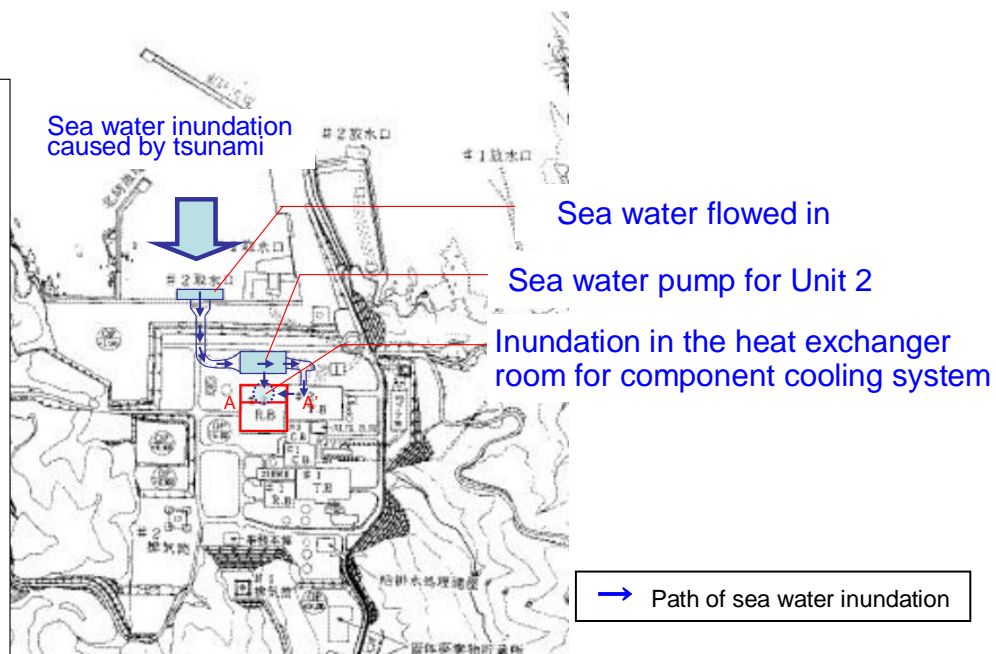
Fig. III-3-5(a) Inundation in the heat exchanger room for a component cooling system (1) at Onagawa NPS.

The observed tsunami height was 13 m, and despite the land sinking, the tsunami did not cause the seawater pump room (on the site as high as 13.8 m, adjusted to sinking by about 1 m) to be directly submerged. However, as the water level rose due to the tsunami, the water level in the underground intake pit also rose as shown in Figure III-3-5, caused by the siphon phenomenon. This resulted in seawater overflowing through the opening of the tide gauge into the seawater pump room. Then the seawater flowed from the pump room, via the trench, into the basement floors of the reactor buildings, causing the heat exchanger room of the component cooling water system in the second basement to be submerged. In addition, the component cooling water pump of Unit 2 was also submerged, which thereby caused the cooling function of emergency diesel generators to be lost, with two units stopped out of those three generators.

Tsunami trace at a height of 2.5m

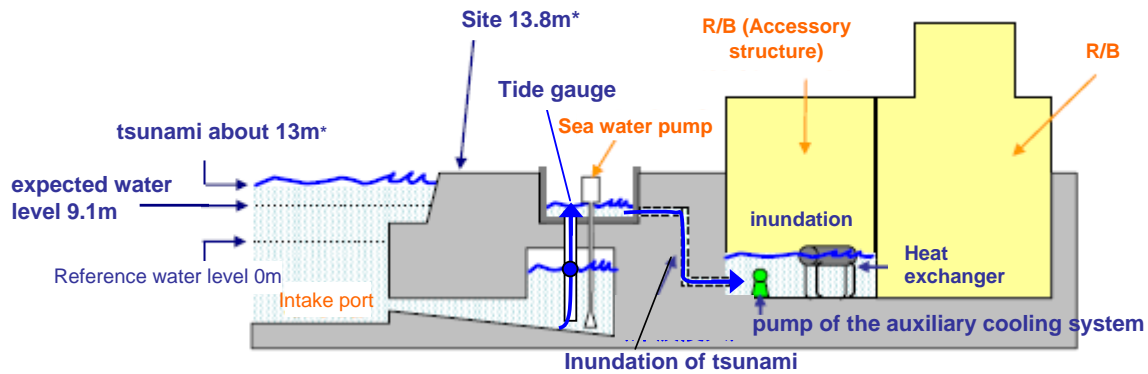
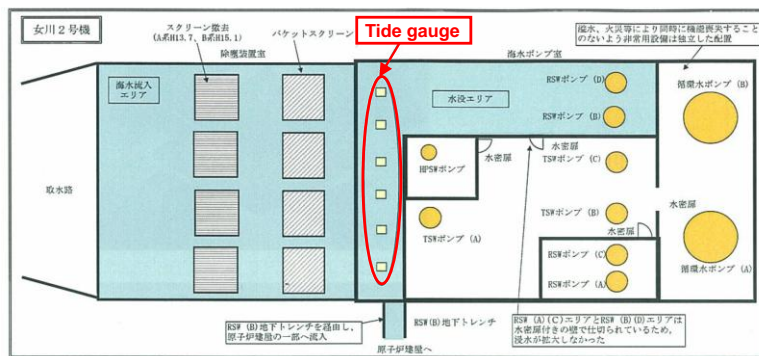
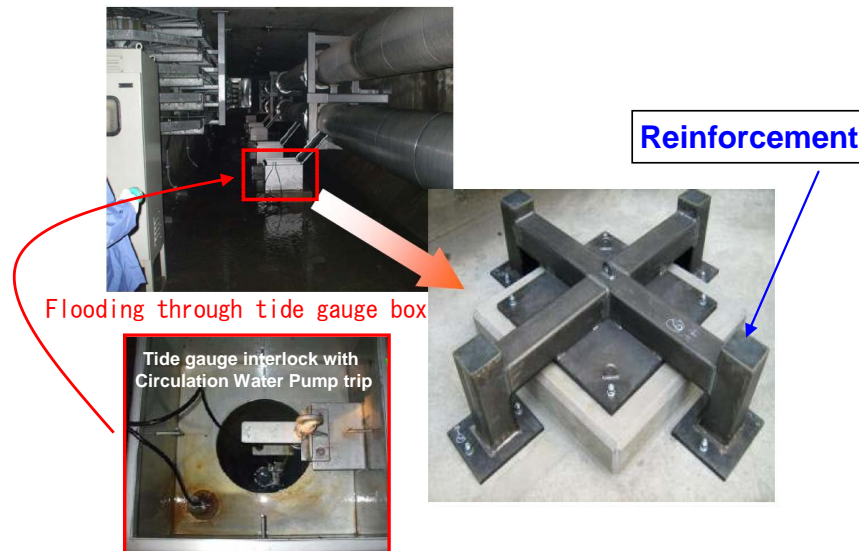
[ Inundation pathway to Heat exchanger (B) room for component cooling system ]

\*Subsidence of 1m at Onagawa site is considered

[ Installation position of tide gauge interlock with Unit 2 Circulation Water Pump trip ]

[ Tsunami countermeasure for tide gauge ]

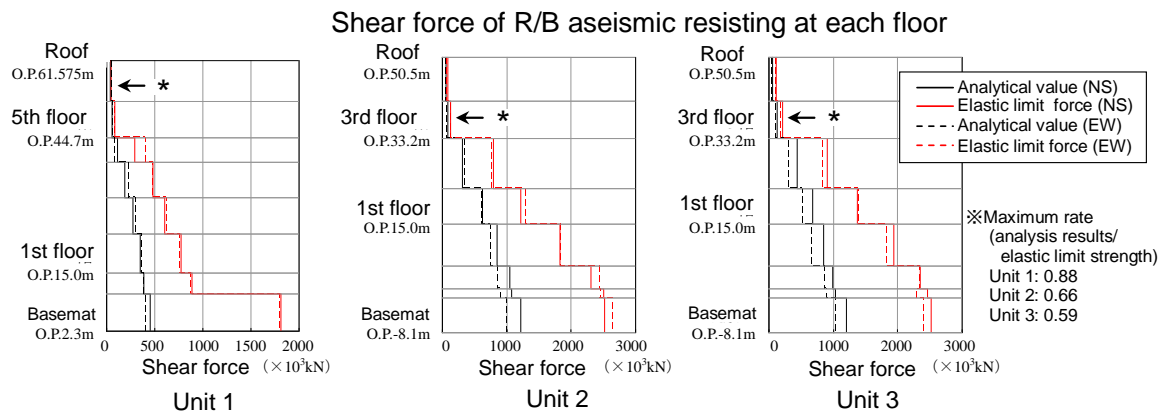
Tohoku Electric Power Company conducted an integrity assessment of the reactor buildings, based on the same procedures as the integrity assessment for the building structure of the Kashiwazaki-Kariwa Nuclear Power Station after the Chuetsu-oki Earthquake in July 2007. The response analyses on the reactor buildings of Units 1 to 3 were made with the observed acceleration records as the input of seismic ground motion. Figure III-3-6 shows the shear strain and shear force at the building by floor for each Unit. It can be seen that shear strain at each floor was below the JEAG4681-2008

Analytical result	Standard Value*	(Comparison) DBGM
Unit 1	NS	$0.36 \times 10^{-3}$	$2.0 \times 10^{-3}$	$0.65 \times 10^{-3}$
	EW	$0.35 \times 10^{-3}$		$0.56 \times 10^{-3}$
Unit 2	NS	$0.49 \times 10^{-3}$		$1.15 \times 10^{-3}$
	EW	$0.28 \times 10^{-3}$		$0.55 \times 10^{-3}$
Unit 3	NS	$0.81 \times 10^{-3}$		$0.99 \times 10^{-3}$
	EW	$0.18 \times 10^{-3}$		$0.41 \times 10^{-3}$

\* Standard values are established in JEAC4601-2008 (Japanese seismic design code for nuclear power plants; Japan Electric Association). They are twice the value of ultimate shear strain for reinforced concrete shear walls as safety factor.
